TOOL / EQUIPMENT BALANCE REPORT

Equip ID: VMB2SiF4 **Building:** E **Date:** November 7, 2022
Project: VMB2SiF4 Install **Functional Area:** CVD
Installing Contractor: ABC Mechanical
PM: Joe Johnson **Room Number:** H Subfab **Balancers:** JB

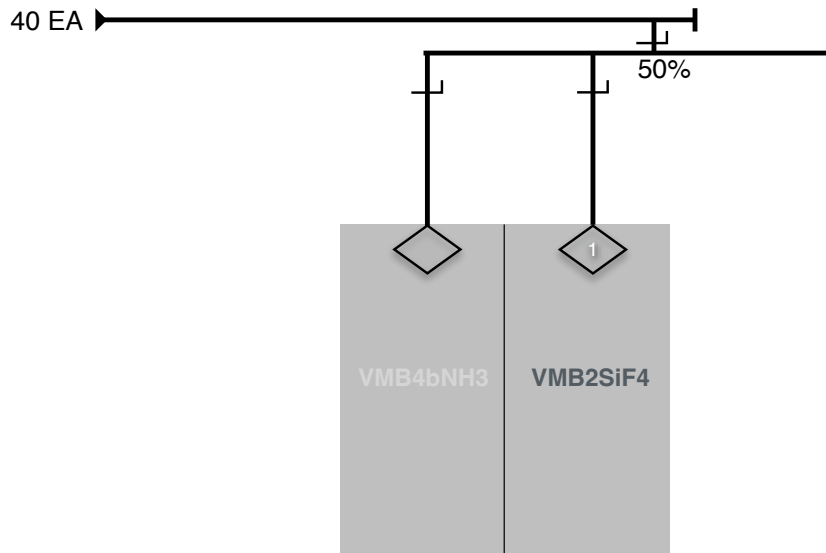
NOTES: This cabinet was set to achieve the design flow, all other criteria exceeds the minimum specifications
 This cabinets does have a damper in the vent at the base of the box that is open 100% open
 VMB4bNH3 cabinet was set at the same time as this cabinet
 A temporary baffle was installed at the face of the port. The permanent replacement will need to be installed in the same location as the temporary baffle is installed. This area is marked on the cabinet.
